**APPLICABLE TO HYDRANT COUPLERS PART NUMBERS:
3" x 4" API – 64800, 64801, 64802, 64804 AND 4" x 4" API –
60700-1, 61525, 64702, 64900 ALL SERIAL NUMBERS
PRODUCED TO DATE AND THE COMMON REPLACEMENT
LOWER HALF PART NUMBER 44665 AND 47245**

**SB016070560
July 5, 2006**

**CARTER 4" API HYDRANT COUPLERS REPORTED
EJECTION WHEN INSTALLED TO "RIGID PIPING
ASSEMBLIES" MANUFACTURED BY HYDRANT
SERVICER BUILDERS**

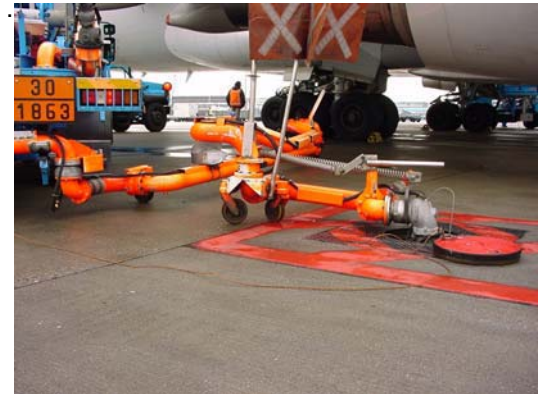
One example of a "Rigid Piping Assembly" showing an incorrect installation.

As I am sure everyone understands, these "Rigid Arms" create a moment (lever) arm that amplifies any force applied on one end of the arm is then multiplied times the distance. (Example: a 400 pound force applied 10 foot away, creates a 4000 foot/pound force at the coupler interface.)

In these cases it was concluded that these failures were the result the "Rigid Piping Assembly" amplifying a relatively small force at one end of the Assembly into a breakaway force at the coupler interface.

Carter requires a minimum of 3 feet of approved aviation hydrant hose be installed between our Coupler and any "Rigid Piping Assembly." Many Hydrant Servicer builders already build within this requirement. However, failure to do so could result in a Carter Coupler's ejection and the related fuel spillage and/or personal injury that could occur. Failure to comply with this requirement also voids our warranty and limits our product liability.

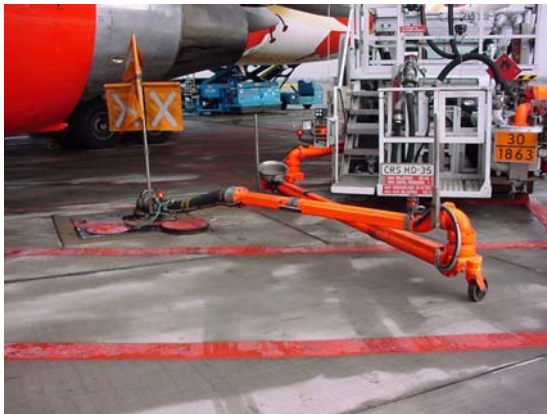
An example of a correct installation of a Hydrant coupler.

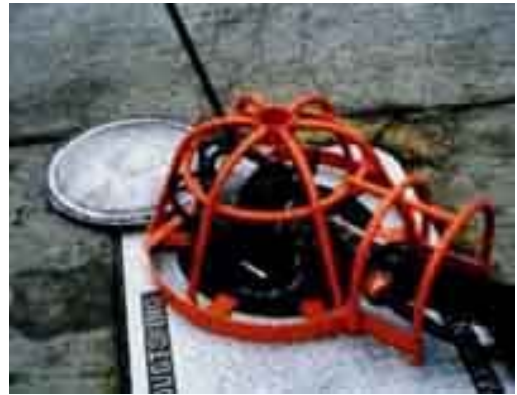
PIT BARRIERS / IGLOOS

Lastly, Argo-Tech Corporation - Carter Ground Fueling Division's official position on the use of pit barriers (igloos) is as follows. Our Couplers are and have always been designed to breakaway cleanly from the hydrant valve if they are either struck by another ramp vehicle or pulled off by the hydrant server. The use of any type of barrier can only further complicate and/or prevent the free breakaway of the coupler and are therefore NOT RECOMMENDED.
